Fire in the Engine Room

Many events led to fire and subsequent casualties.

by MS. BETTY LYNN SPRINKLE
Special Correspondent to *Proceedings*

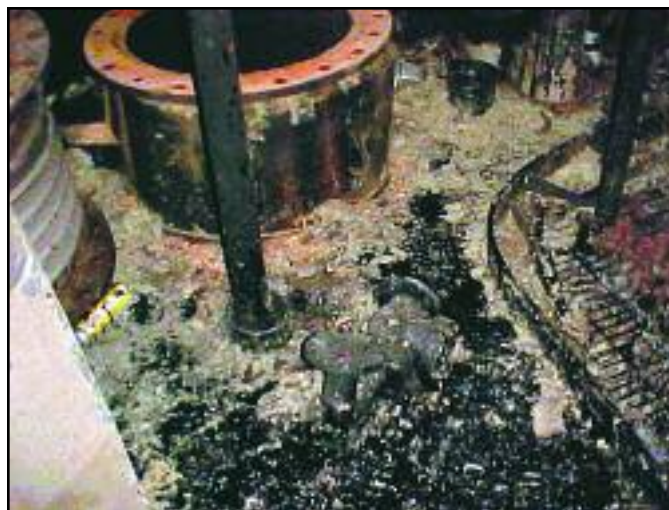
and covered the solid deck plating. Eventually the combined fuels spilled over the first level deck coaming and onto the auxiliary boiler exhaust stack. The exhaust stack was hot enough to ignite the fuels. The resulting fire sent intense heat, black smoke, and flame through the aft levels of the engine room and inside the fidley. The diesel and heavy fuel oil mixture

Residual oil on deck in the vicinity of the incinerator exhaust stack of the 03 level of the engine room. Fire damage is visible in the surrounding area. USCG Photo.

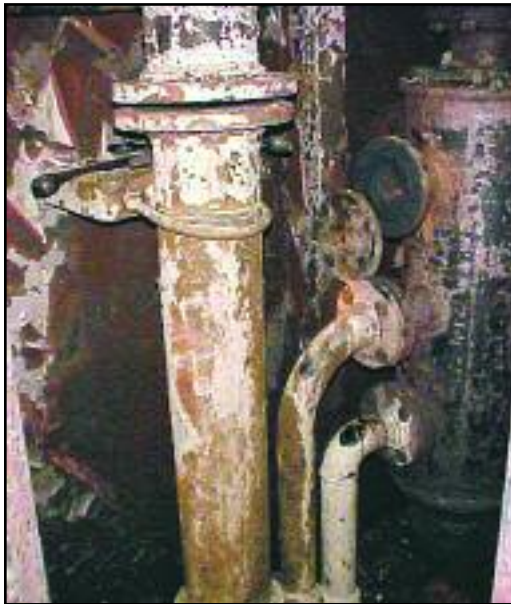
Five-inch drain line from the HFO fuel tank vent collection chamber on the 03 level of the engine room. USCG Photo.

The engineers disconnected a venting pipe for maintenance two days prior to the fire and

it was not reconnected before starting the transfer of fuel. No warnings were placed to prevent using the HFO transfer pumps while the vent was disconnected. The engineers failed to trace the lines they were disconnecting or to notify the master that they were performing such maintenance. A great deal of damage from the fire was found in the area where the disconnected vent pipes were located.

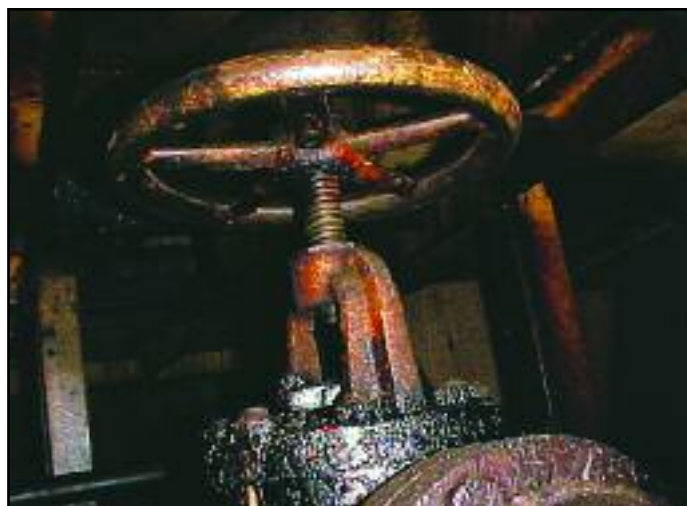
Open discharge valve from HFO (Heavy fuel oil) transfer pump in the lower level of the engine room. Oil and fire damage is visible. USCG Photo.

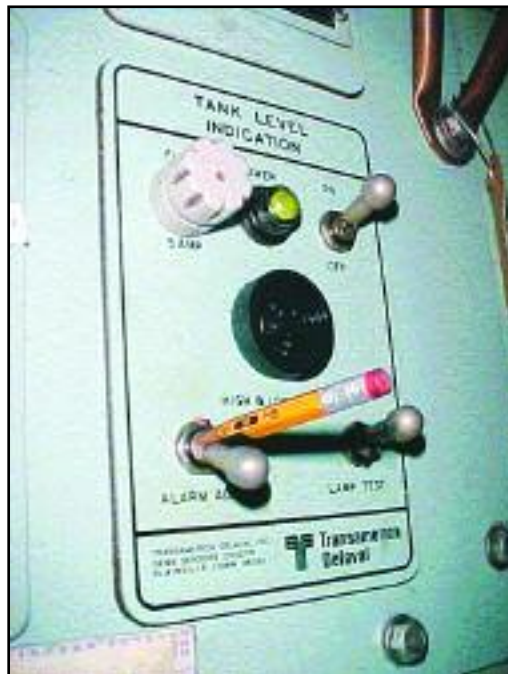
Several situations contributed to the cause of the fire and complicated its containment. A device that monitors the storage tank overflow had been malfunctioning for several weeks, causing false alarms. The alarms had been disabled and did not alert the crew that the storage tanks were overfull. The engineers knew about this situation, but did not attempt to repair it, nor did they alert the master to the situation. These actions bypassed critical safety features of the system.

A pencil wedged into the High Tank Level Indicator audible alarm panel. Position of pencil holds switch in "Acknowledge" position. The alarm would never sound to warn of a high tank level when the switch was in this position. USCG Photo.

While the untended transfer of fuel oil is the primary cause of this casualty, many factors contributed to the engine room fire and subsequent events. The method of dealing with the tank level indicator and false alarms prevented personnel from having accurate information about the storage tanks. A lesson to be learned from this is that alarm and safety devices are placed in systems for a purpose, and engineers and crew bypass them at their peril.

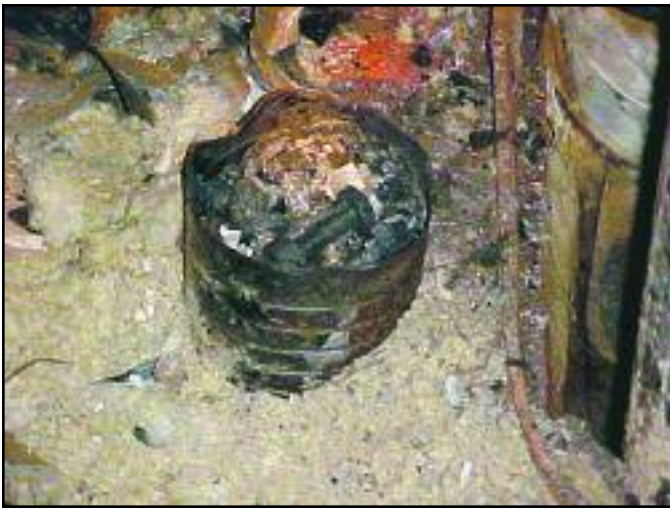
Fire damage to equipment and gear on the 03 level of the engine room. USCG Photo.
